# Effects of adverse weather on airport operations

# Aerodrome Manual

National Civil Aviation Agency - Brazil

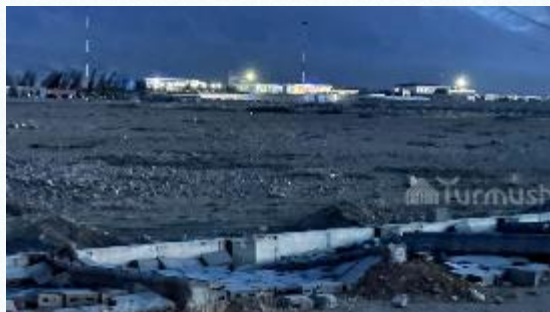
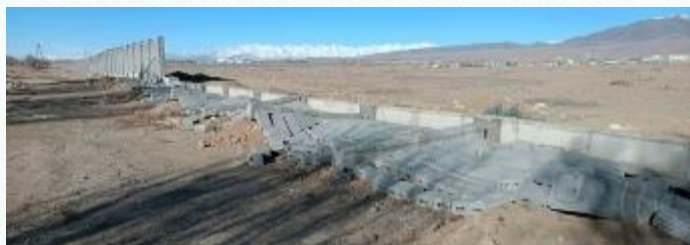
## Issyk-Kul International Airport (Kyrgyzstan, 2024)

- Gusts knock down 90 m of perimeter fence
- Direct risk to operational safety

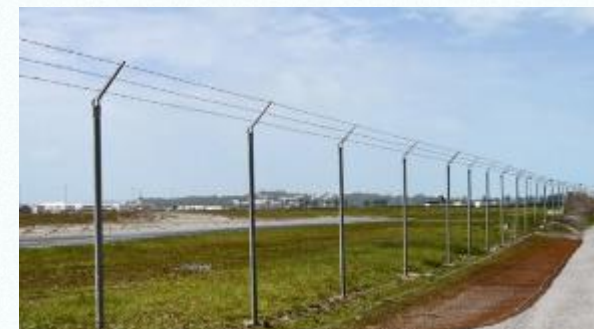
## L.F. Wade International Airport (Bermuda, 2010)

- Strong winds damage perimeter fence
- Entire sections were destroyed

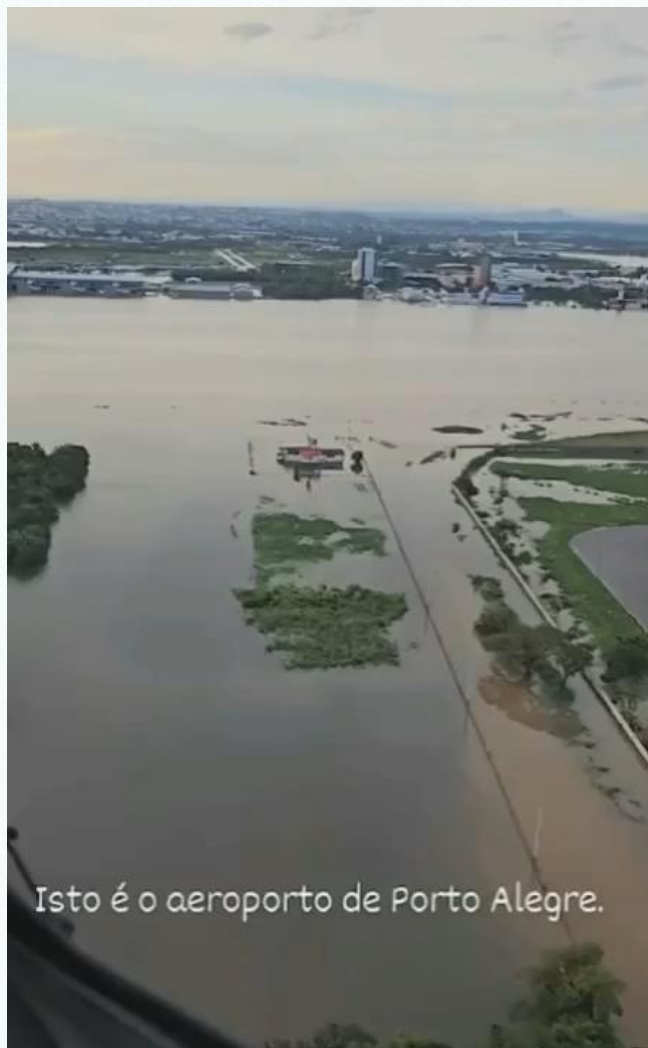
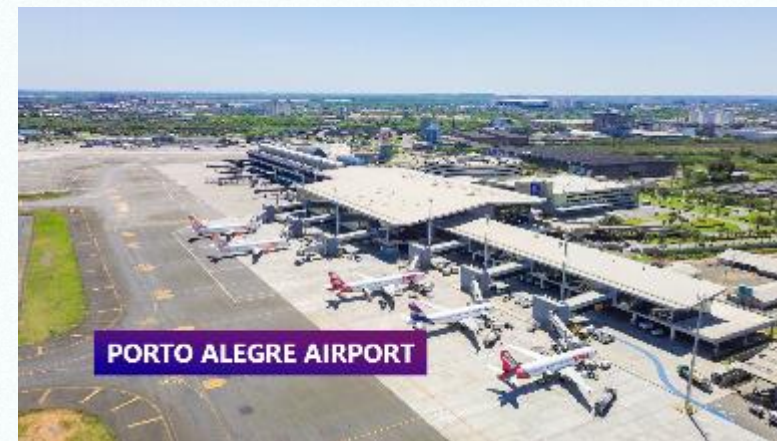
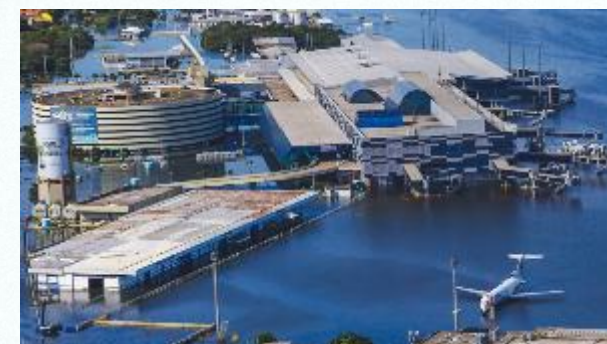
## 2024 Porto Alegre Salgado Filho International Airport, Brazil 2024

- Rainfall record: 417 mm
- Lake Guaíba exceeded 5.3 m
- Airport under 2.5 m of water
- Insufficient drainage aggravated the impact

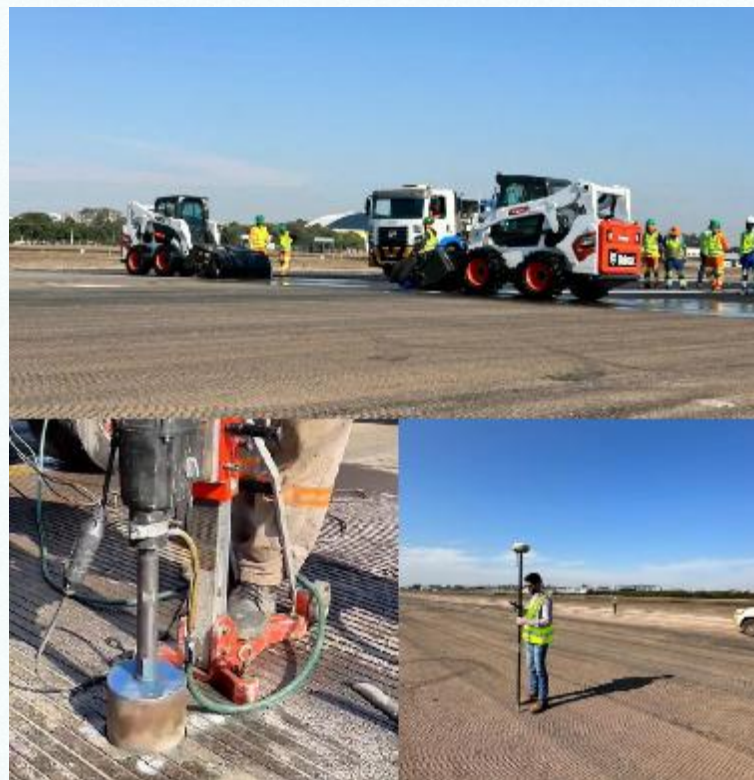
- Comparative tests for 45 days
- FWD to simulate aircraft cargo
- Pavement scanner: detailed mapping
- Severe damage from prolonged immersion (23 days)
